EXAMINATION OF CONDITION OF HISTORICAL TRANSPARENT STRUCTURES OF THE PUSHKIN STATE MUSEUM OF FINE ARTS

ABSTRACT

The article describes the results of the second part of examination related to transparent structures of the Pushkin State Museum of Fine Arts: the lantern lights. The structures are cultural heritage of federal importance and are subject to state preservation. Based on the results of comprehensive examination, the conclusions were made that these structures are in unsatisfactory condition and materials were prepared for development of recommendations concerning their restoration.

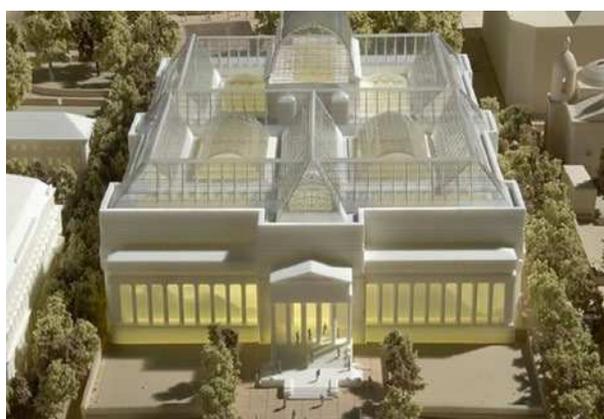
Fig. 1. illustrates the scale of the transparent structures of the Pushkin Museum.

Fig. 1. Model of the main building of the Pushkin State Museum of Fine Arts

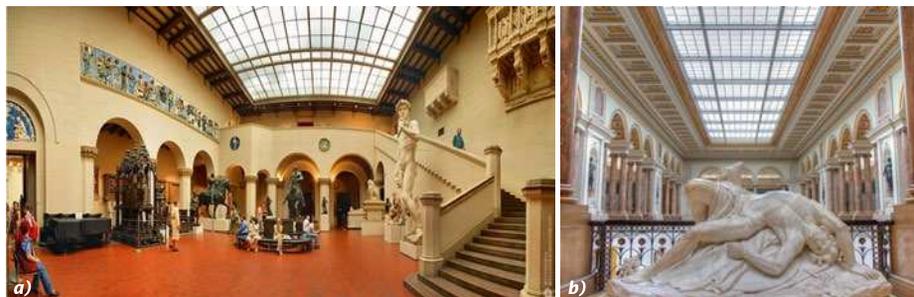
Fig. 3. Systems of natural lighting of museums: a – one of the halls of the Pushkin State Museum of Fine Arts; b – similar hall of the Lille Palace of Fine Arts

Diffusing opaque glass (with rather dense frosting) in the *ceiling* is installed horizontally on the same metal T-profiles with cross-section dimensions of (35×35×3) mm as the other elements of the transparent structure (Fig. 11). Its view from the exhibition halls is shown in Fig. 3, *a*.

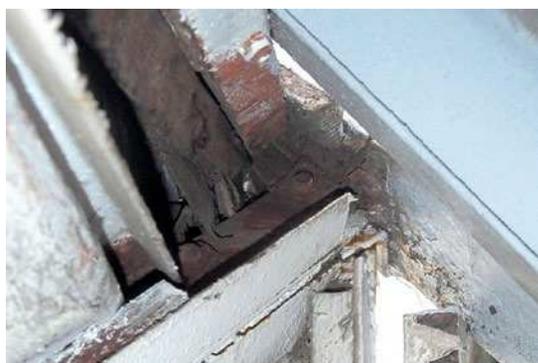
Fig. 4. Roof beam joint with traces of corrosion

The dangerous to use sections are primarily the areas of strong (up to 100 %) corrosion of joint plates, angle legs and inclined elements connecting the frame work to the walls of the building as well as thread stripping of bolts. Such areas are located primarily at corners of the buildings, in the vicinity of neck gutters and ridge part of frame works.

For illustration of the conclusions of the study [8], only one example is presented below (Fig. 4).

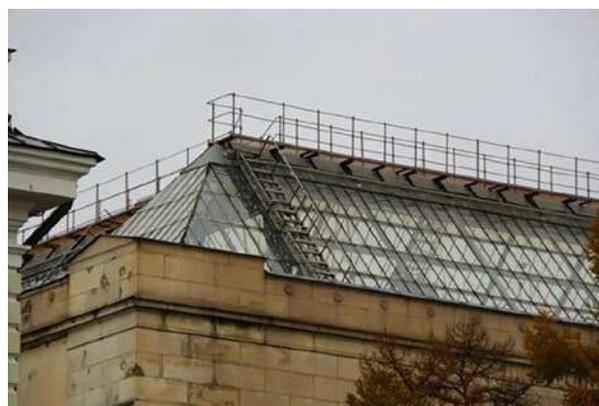
Fig. 6. Exterior of the transparent structure in 2018

the structures were installed during construction of the museum in the beginning of the previous century (some restoration works were performed in the 1960–1970’s). Fig. 6 shows contemporary exterior of the transparent structures of the museum.

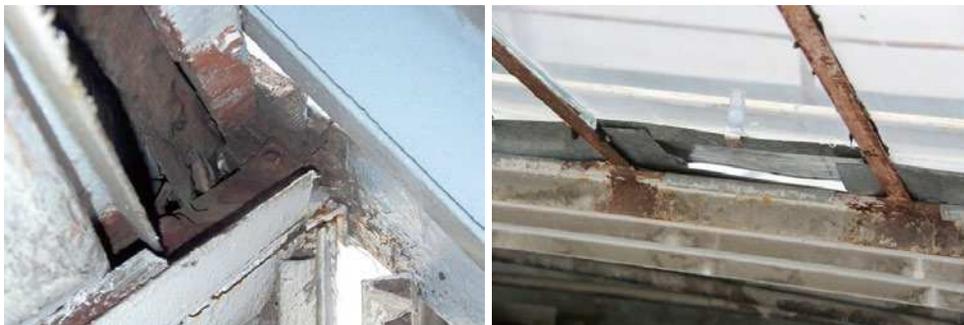
Fig. 7. Elements of the lantern light structure in 2018

The current state of the structural elements of the main element of the museum’s transparent structure (*lantern light*) is shown in Fig. 7.

- The roof pitches are made of glass fragments with thickness of 4 mm (average dimensions of glass fragments are 415×1110) mm), the pitch is 50°;
- The glass fragments are installed on T-profiles (35×35×3) mm which are supported by horizontal steel angles (90×10) mm;

- The main frame works are made of two welded (bolted?) beam channels so that they actually have a profile of an I-beam;
- Dimensions of the frame work cross-section are as follows: width of 150mm, height of 140 mm, thickness of 5 mm to 7 mm (depending on thickness of the coating applied over the previous 100 years);

- Spacing between the frame works is not uniform and its average value is 2,850 mm;
- The height of the ridge of main element of the triangular lantern light from the floor of the roof space is about 8,000 mm and that of the semi-cylindrical lantern light is 10,000 mm;

- The glass fragments are installed with higher fragment overlapping the lower one (like roof tiles) with a small spacing providing both additional ventilation and natural removal of condensate generating on the inner surface of glass (V.G. Shukhov’s idea);

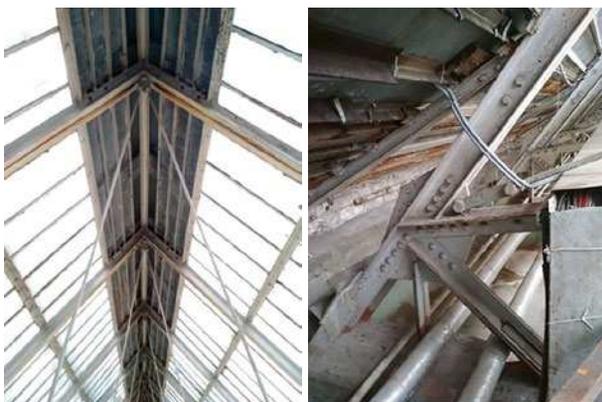
Fig. 8. Ridge of the lantern light transparent structure and traces of repairs

- The ridge of the roof has numerous traces of leakages and patching up with poor quality (Fig. 8);

- In the course of maintenance of lantern light glaring, glass was replaced by plywood sheets and/or galvanised steel sheets (Fig. 8);

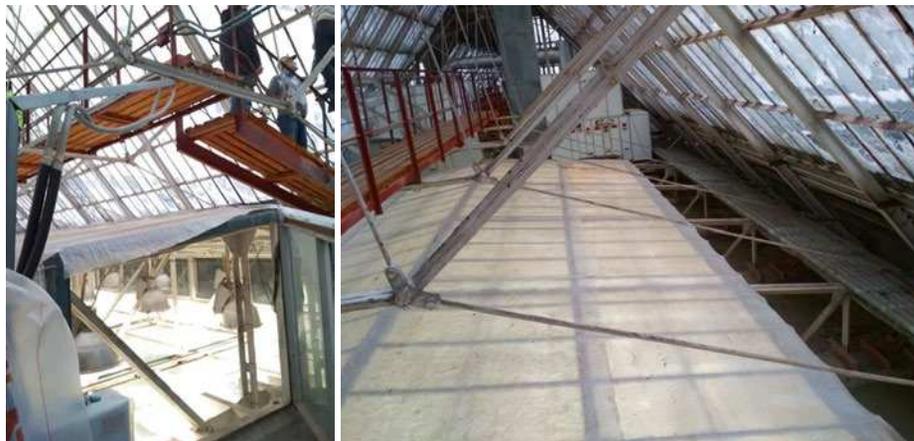
Fig. 10. Inner space and exterior of the sub-lantern

Current state of the sub-lantern glaring absolutely does not comply with its intended use, i.e. provision of natural lighting of exhibition halls. That is

why there are numerous additional light sources installed in the space between the diffuse ceiling and the sub-lantern (Fig. 10).

For prevention of leakages to the main halls, the sub-lantern is currently covered by fabric, polymer film, etc. (Fig. 10).

Due to the constant leakage, the profiles on which the glazing of the side panel is corroded and need to be replaced and or deep cleaned and coated with special compounds
