## THE RECONSTRUCTION PROJECT OF LIGHTING DEVICES AT THE KRASNOSELSKAYA STATION OF THE MOSCOW METRO

Ksenia I. Nechaeva

*ILEC "BL GROUP" LLC, Moscow, Russia*  
*E-mail: ksunechaeva@yandex.ru*

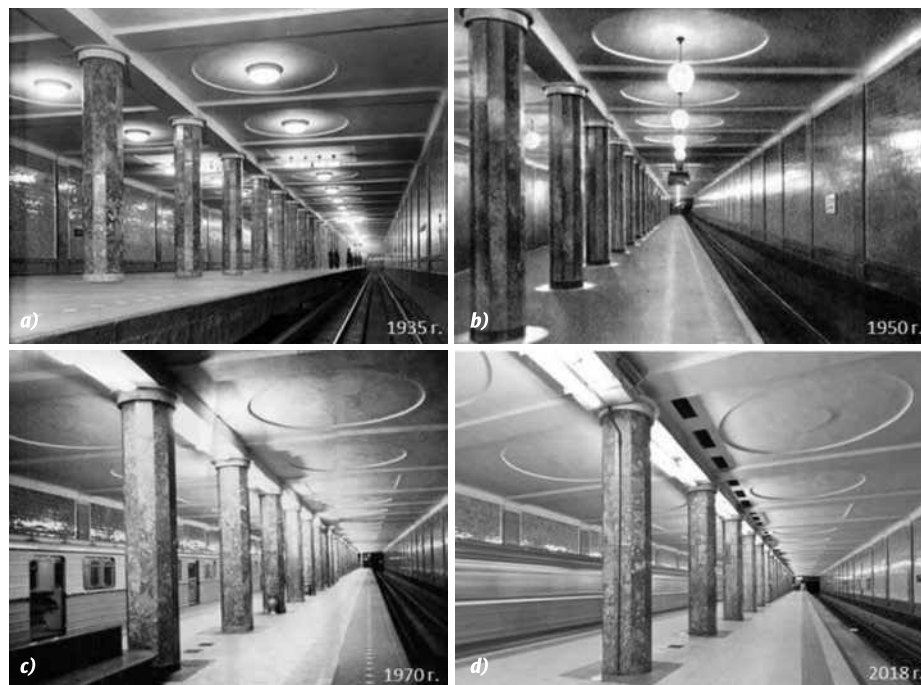
Fig. 2. Appearance of the platform at Krasnoselskaya station: (a) 1935, (b) 1950, (c) 1970, (d) 2018

changed the station appearance which was not for the better (Fig. 2). Meanwhile, lighting modernisation has led to the fact that existing LIs do not meet any modern lighting regulations [1], which is absolutely unacceptable. After all, the Moscow Metro today is a space, where thousands of people move every day, and ensuring their safety is the primary task for lighting reconstruction.

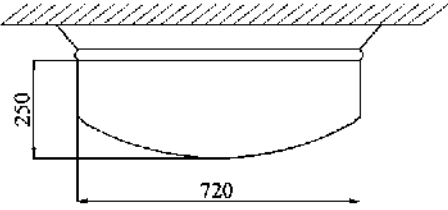
No.	Luminaire name	Luminaire draft	IL quantity and power (pieces × W)	Efficiency (%)
1	Dome lamp $D = 720$ mm

It is known that (60–150) W incandescent lamps (ILs) were widely used as a light source in typical LDs of the first Moscow Metro stations [2]. Two types of LDs were used to illuminate the platform hall at Krasnoselskaya station; their main specifications are presented in Table 1. It was decided to replace round dome lamps with hanging balls in the 1950s; IL LDs were replaced with fluorescent lamp (FL) LDs later in the 1970s. As a result, the plat-

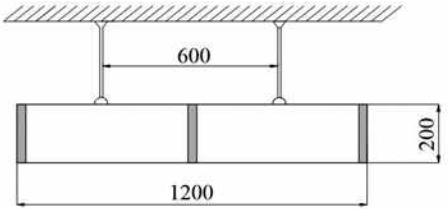
6 × 100 6 × 150	55
2	Hanging cylinder

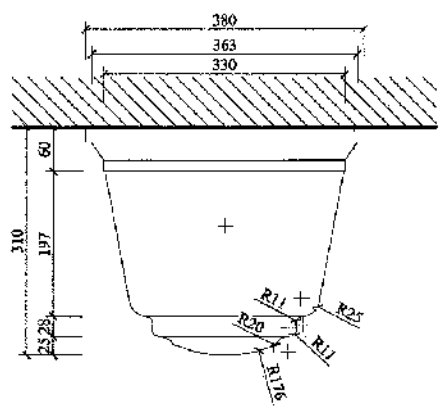
6 × 60	67
3	Passing zone luminaire

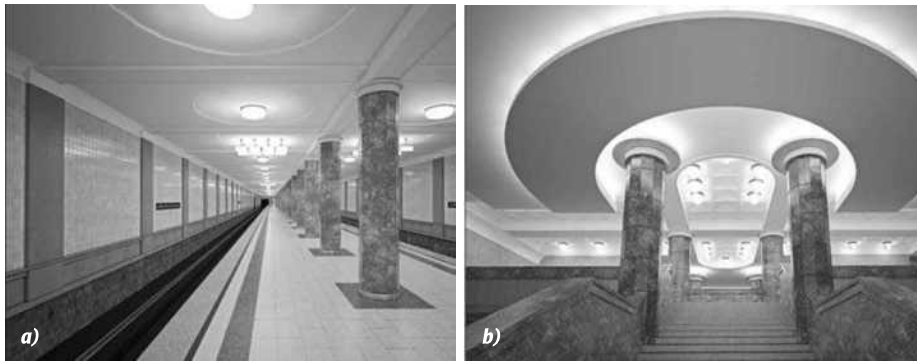
Fig. 11. Visualisation of Krasnoselskaya station with the proposed LI: (a) platform hall, (b) stair flight of the connecting passage

The above LDs were modelled in *Solidworks* [8]; *IES* files and luminous intensity curves (Figs. 8b, 9b) were obtained using the *Photopia* plug-in [9]. According to the results of lighting calculation carried out with regard to the properties of the proposed devices and based on result visualisation, it can be concluded that the station appearance with such lighting reconstruction becomes the original idea of the architects (Fig. 11). The new LI allows not only to identify the main architectural elements

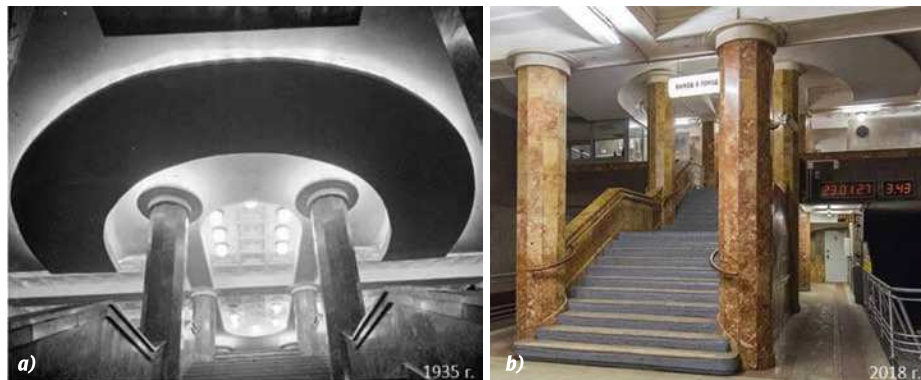
Fig. 3. Appearance of the connecting passage stairway at Krasnoselskaya station: (a) 1935, (b) 2018
