INSPECTION OF THE STATE (GENERAL AND INSTRUMENTAL) OF HISTORICAL TRANSLUCENT STRUCTURES OF THE PUSHKIN STATE MUSEUM OF FINE ARTS

Alexander V. Spiridonov and Nina P. Umnyakova

*Research Institute of Building Physics of Russian Academy
of Architecture and Construction Sciences, Moscow
E-mail: spiridonov@aprok.org*

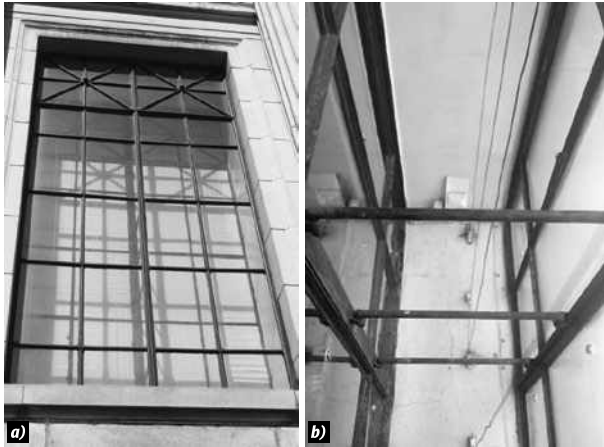
Fig. 2. Historical windows in the major building of the Pushkin State Museum of Fine Arts:
a – view from the outside, *b* – metal bonding (“ladder”) between external and internal sashes

made at the beginning of the last century (Fig. 2). They are external and internal massive steel sashes with a single glass thickness of 6 mm, spaced by 0.5 m. Most of the translucent first floor structures installed around the perimeter of the building have the dimensions of about 1560 (width) × 3740 (height) mm.

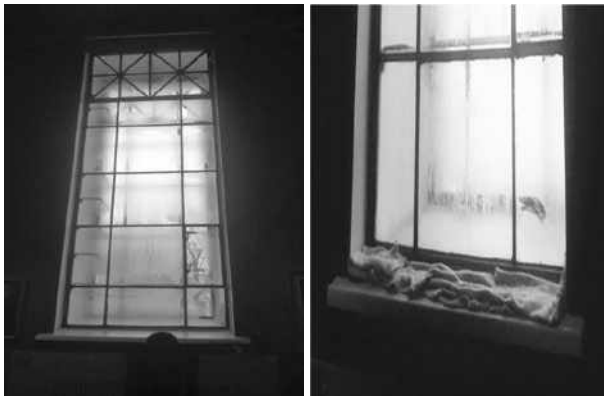
Fig. 3. Condensate formation on the inner surface of translucent cladding

The surveys were conducted several times in different periods of the year – from February to June 2018. When conducting a visual examination on February 26, at the external air temperature $t_e = -15\text{ }^\circ\text{C}$, the internal air temperature $t_i = +20\text{ }^\circ\text{C}$ and the relative humidity of the internal air (52–63)%. In almost all rooms on the inner surface of all windows, there was abundant condensation from top to bottom, flowing down to the window sill and even to the floor (Fig. 3).

The condensate on the interior surfaces of translucent structures is absolutely unacceptable in the premises where the works of art are exhibited. In addition, moisture on the windows and slopes contributes to the appearance of mildew and fungi on the inner slopes of windows, which is also not useful for paintings – they can also be infected.

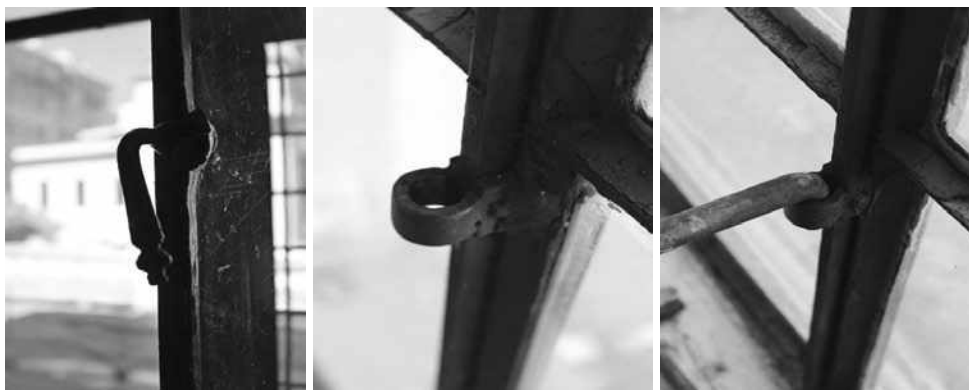
The survey of historical translucent structures revealed the following (Figs. 4 and 5):

Fig. 5. Elements of historical translucent structures

- External and internal frames are made of sufficiently material-intensive corner iron, U-bars, T-bars, I-beams and shaped profiles;
- Ordinary transparent glass with a thickness of 6 mm is installed on external and internal frames;
- Translucent structures are installed in light openings without thermal insulation layers;
- The basic vertical imposts of window structures are very massive, and there are very strong corrosion processes inside;
- Under the blind casing on the internal frame structures, which are made with the use of sufficiently massive corner iron, the extensive corrosion damage is detected (probably the inner angle elements are to be replaced – they are almost decayed);

– In order to provide natural ventilation of exhibition premises in the early last century in translucent structures the ventilation windows were provided, which – in addition to exclusively original fittings – today (with the equipped air conditioning systems in the near future) are completely useless and even harmful.

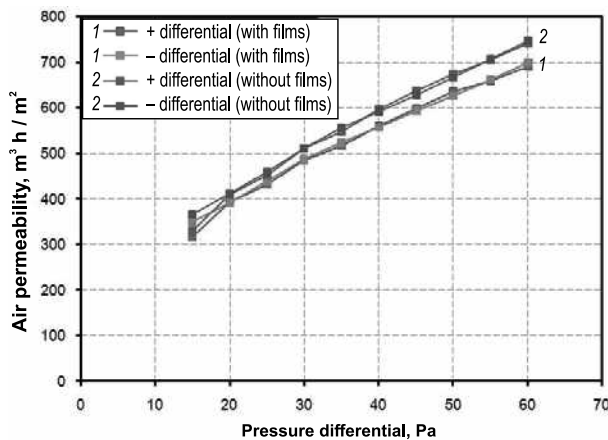
Fig. 8. The values of air permeability of the premises at positive and negative Δp

The testing of the historical translucent cladding for air permeability was carried out in the utility service room of the restoration workshop. The doors and other possible air infiltration areas were sealed before the testing. The “Blower Door” complex was installed in the doorway. The testing was carried out according to national standard [7]. Positive and negative differential air pressure Δp equal up to ± 60 Pa respectively were set during the full-scale testing. At each Δp value air permeability measurements were made. Then, on the basis of the obtained data, the air permeability values of the window at different Δp were calculated (Fig. 8 and Table 2).

As a result of the conducted surveys of historical translucent structures, it became obvious that they do not comply with the current requirements, neither on heat transfer resistance nor on air permeability. In case of preservation of metal window frames (according to the requirements of the law on protec-

tion of cultural heritage sites) the large-scale computer calculations should be performed to determine the best ways of window restoration.
